Home Report

**Flat 2 Hazelwood House
Hazelwood Road
Hawick
TD9 7QR**

Single Survey

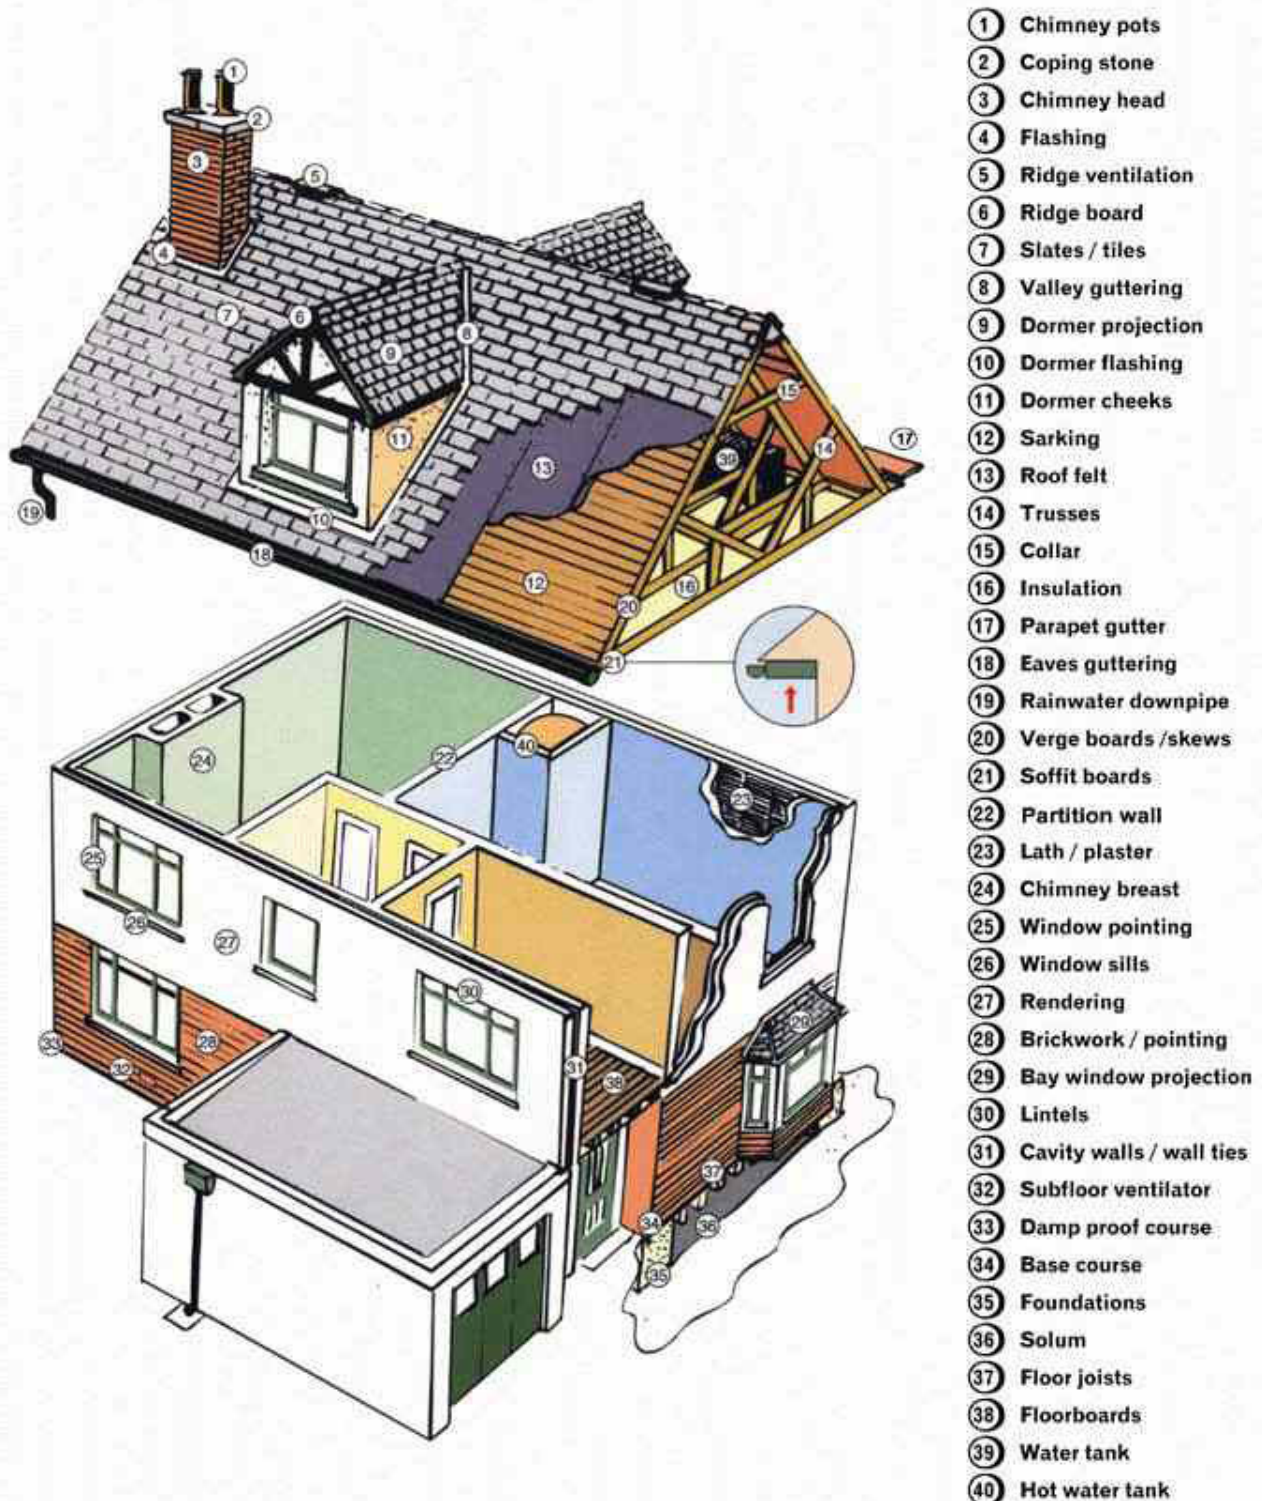
Sectional Diagram showing elements of a typical house

Reference may be made in this report to some or all of the above component parts of the property. This diagram may assist you in locating and understanding these items.
